# THE MOBILE AIR CONDITIONING SOCIETY WORLDWIDE

## MACS Service Reports

April 2004

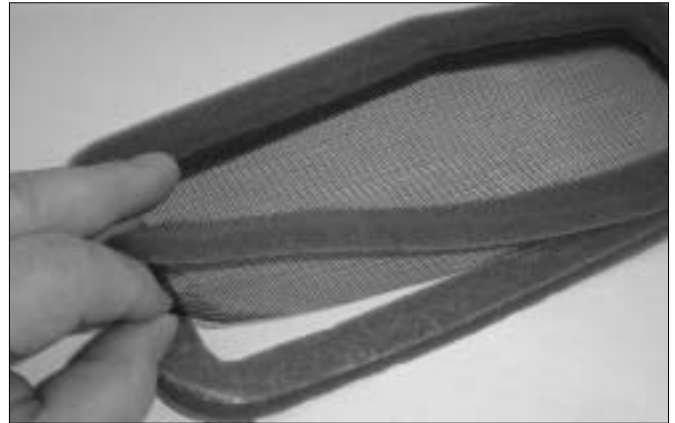
**Figure 2.** An air intake screen can be made from fine-mesh household screen sandwiched between layers of two-sided adhesive foam gasket material.

Now, General Motors is planning to release a line of screens for those vehicles that don't have cabin air filters at the outside air intake, and in the interim is suggesting you make your own (Figure 2). GM actually is more concerned about debris damaging the blower motor; up to 70 percent of blower warranty is caused by debris ingestion.

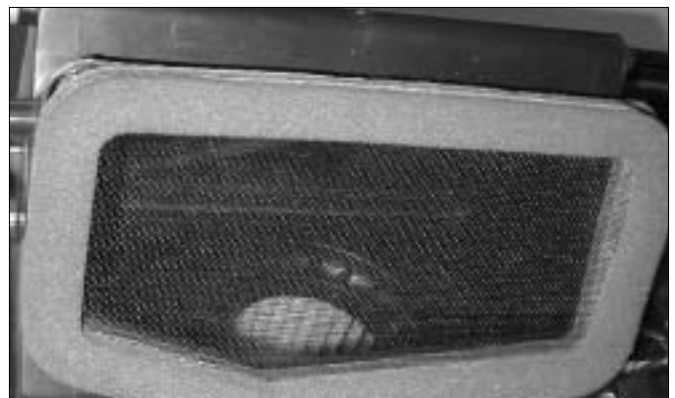
**Figure 3.** This air intake screen on a Saturn VUE gives you an idea of what GM is planning to release as a service part, and possibly as original equipment on vehicles without an air intake filter.

The screens reportedly will be similar to the type that Visteon supplies for the Saturn VUE (Figure 3).

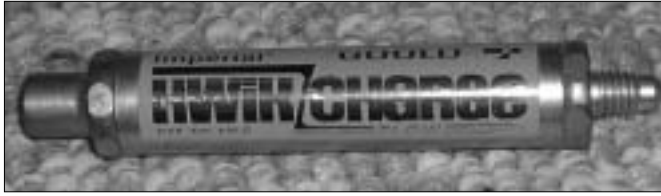
**Figure 4.** This is the old “Kwik-Charge,” which was sold to prevent compressor slugging from liquid charging into the suction side. We bought it in the days of CFC-12. It apparently has some sort of restriction to meter droplets of liquid refrigerant, and (what sounds like when we shake it) an anti-blowback valve in case it was connected to the high side.

Most systems have anti-slugging protection for the compressor, such as valves and accumulators, but “an attitude's an attitude” and manufacturing engineers often get the final call — even if briefly. Old-timers may remember our fears about liquid slugging and our impatience with vapor charging way back in the CFC-12 days. If you're in that class, you may remember the Imperial Kwik-Charge, a gadget that was supposed to allow liquid charging safely, by metering droplets into the low side. Did it really work? Don't know, only that we used it and never seemed to slug a compressor (Figures 4 and 5).

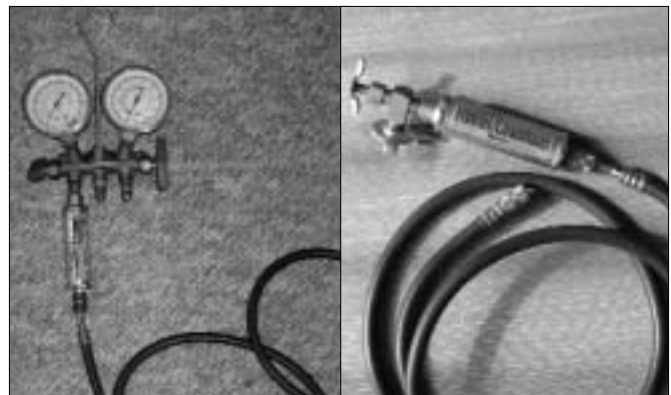
**Figure 5.** The “Kwik-Charge” inlet side was supposed to be threaded into the low-pressure gauge's male fitting on the gauge manifold (at left), with the service hose threaded onto the device's outlet and to the suction side service valve. More often, it was in line with the end of a small can tapper and service hose, as shown at right.

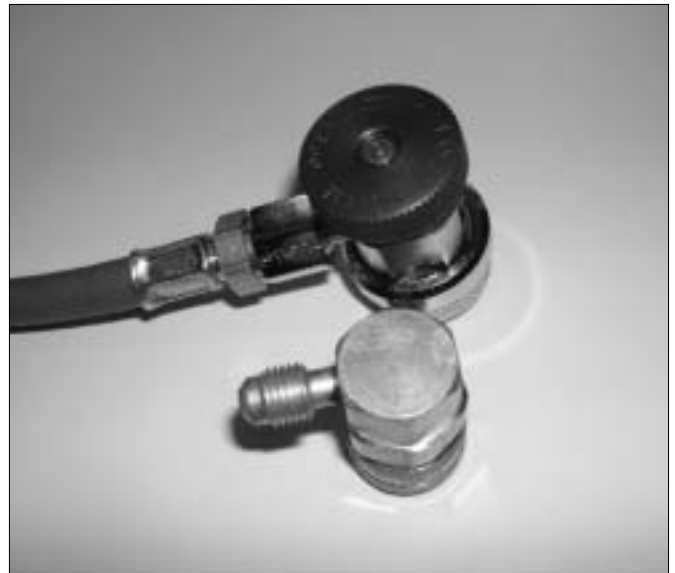
*Figure 6. Two service hose couplings. The knurled knob on the larger one permits you to first install the coupling on the service valve, then turn the knob to push open the valve. The smaller one, although it goes into tighter quarters, may be more difficult to install because it requires a single push-on operation.*

We noted the existence of ultra-compact service couplings (Figure 6) in the March, 2004 issue. These may fit in, but you have to push them on so they also depress the pin. They don’t have the knurled knob, which allows you to simply install the quick-connect and then manually turn the knob to depress the service valve pin. So unfortunately, they usually aren’t as easy to use in the tight quarters in which only they fit. An ultra-compact service coupling with a turn-down depressor would be a nice development. Of course, there are cases where you have to remove a pressure switch that’s on a Schrader-type service valve, then install an HFC-134a adapter. There you might be able to install the service coupling on the adapter first, and thread the assembly onto the “Schrader.”

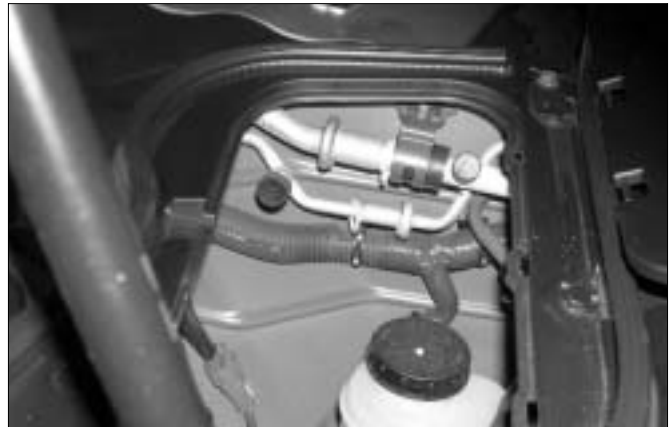
**Figure 9.** The cover is off and there's the brake fluid reservoir, all right. But both A/C service valves are there too.

On the new Infiniti FX35 and FX45 SUVs, the underhood has the typical plastic look. Ignore the labeling on the BRAKE FLUID cover, lift it up and although the brake fluid reservoir is there, so are both A/C service valve fittings, nicely accessible (Figures 8, 9).

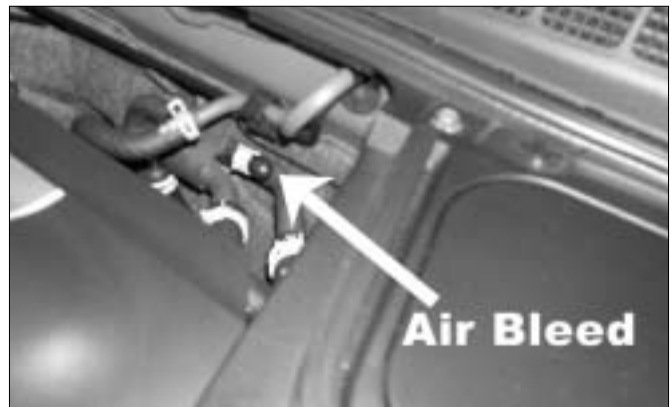
**Figure 10.** In the small open area between the plastic and the cowl is this air bleed for the heater circuit on the Infiniti FX. We've seen this type on other Japanese cars too; if you have an air pocket causing poor heater output, it's worth trying to find a bleed.

And if you ever have to cure a low heat complaint on this vehicle, maybe the problem is an air pocket. There's an open-access air bleed plug up against the cowl (Figure 10).

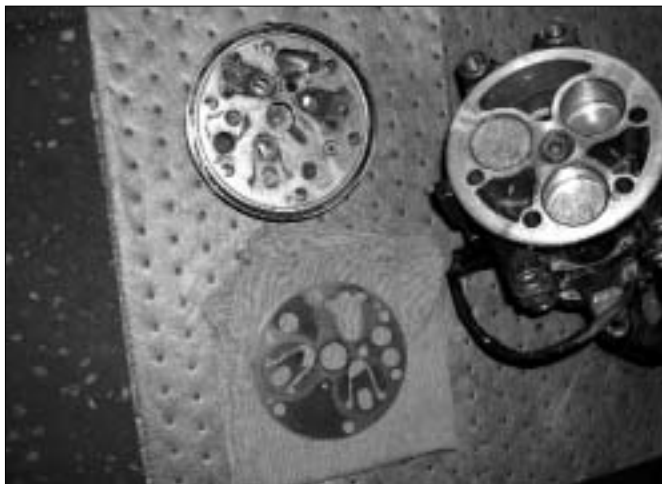
**Figure 11.** This compressor failed to perform for obvious reasons: broken suction reed valves. Could chunks of suction reed have blown back into the low-side hose? It didn't seem to have a restriction, but with this evidence from the compressor, why take a chance? Yes, the technician installed a suction screen to protect the new compressor.

stuck in the hose and later been loosened, going toward the new compressor. Sure, that possibility may occur to you if you take apart the failed compressor and see the damage (Figure 11).

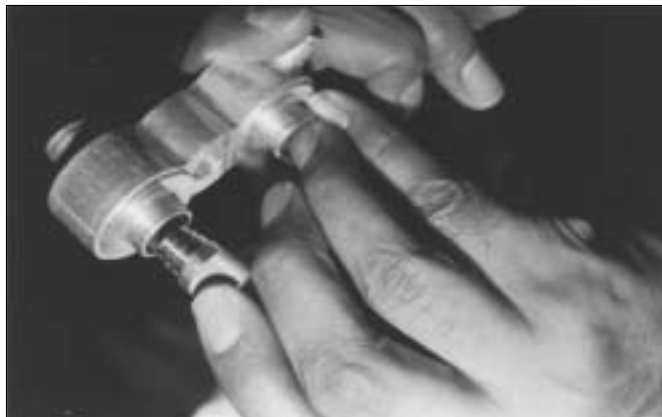
**Figure 12.** The AirSept kits use sizing gauges that enable the technician to pick the right screen for the compressor manifold's suction port. The early kits with three screens were for GM systems with Delphi compressors and the sizing gauge (shown) has just three steps. If this is used for other than Delphi compressors, you could select a wrong-size screen. The new kits, with eight screens, span a greater range and cover most systems, and contain a double-end design sizing gauge with a total of eight steps. However, most is not all, and even if the screen is supposed to fit an application, an occasional out-of-tolerance manifold port might not hold a screen. But the gauge tells you.

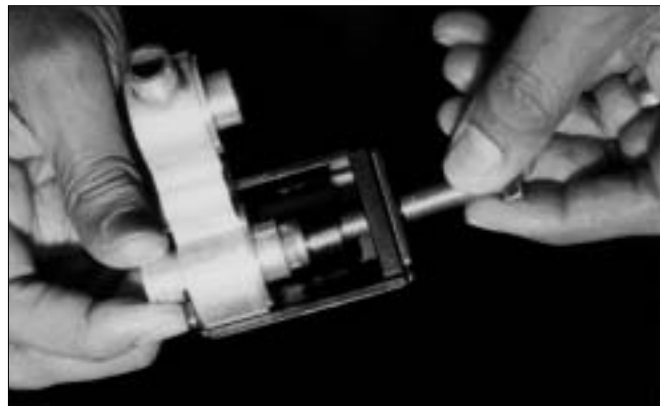
**Figure 13.** If you can push the screen in easily with your thumb, it's probably the wrong size. The screen should require press-in installation with this special tool.
